# Enhancing Project Quality by Implementing Lean Construction and Building Information Modelling Techniques

Heru Andraiko<sup>1</sup> and Agyana Tua Munthe<sup>2</sup>

**Research Method:** We used observation and interview methods on the PGRI Semarang University apartment project. Work quality was assessed using the QPASS (Quality Product Assessment) measuring tool.

**Paper type:** Case Study.

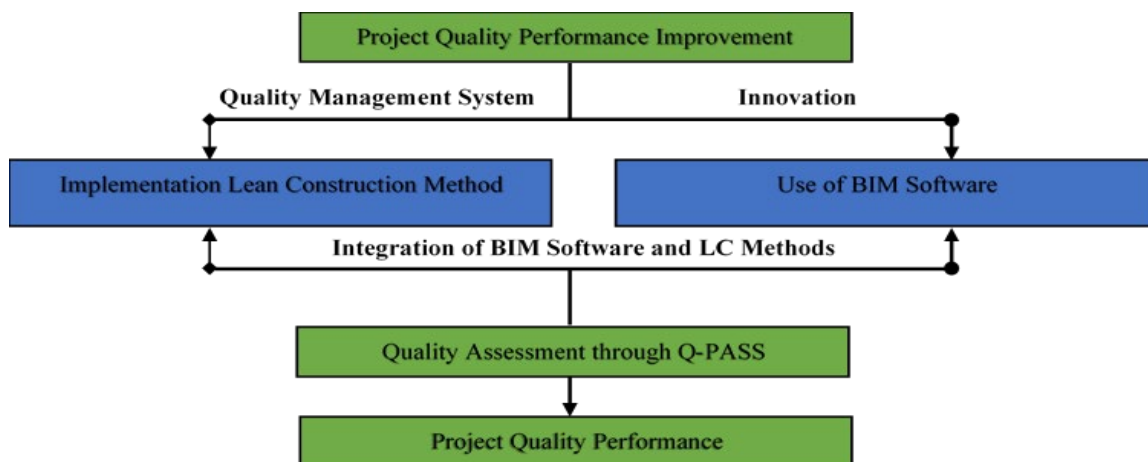
Figure 3: Research framework

The image above shows a research flow plan using two integrated methods. The results of the integration of these two methods will be assessed for quality using the QPASS method. QPASS is a method used by a government-owned construction company in Indonesia to measure the quality performance of ongoing projects. QPASS measures quality by conducting field inspections, evaluating structural, architectural, mechanical, electrical, and plumbing (samep) works, and assessing how consistently the quality management system is implemented, including the 5Rs (Ringkas, Rapi, Resik, Rawat, Rajin)<sup>3</sup> and occupational safety

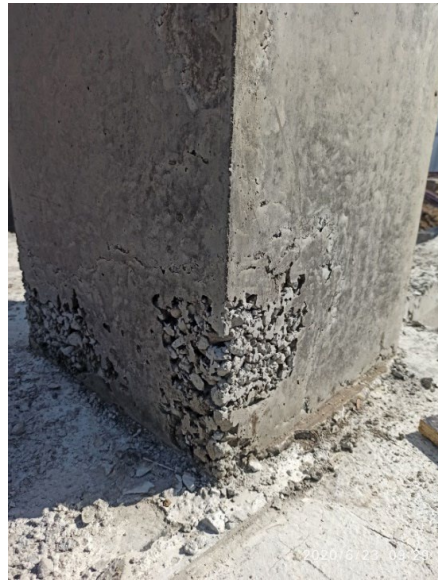
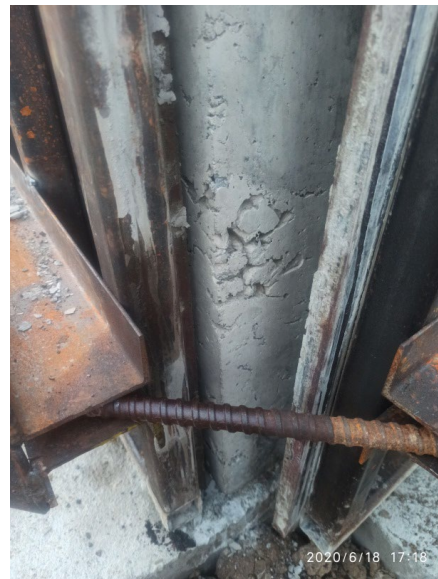
Figures 6 and 7 demonstrate the appearance of quality defects following the casting of the columns. This is due to the lack of coordination in the field so that the planned quality is not in accordance with the expectations of the quality produced. The deviation from the Standard Operating Procedure results in suboptimal quality production. The following image shows the ironing process that is not in accordance with the applicable work instructions.

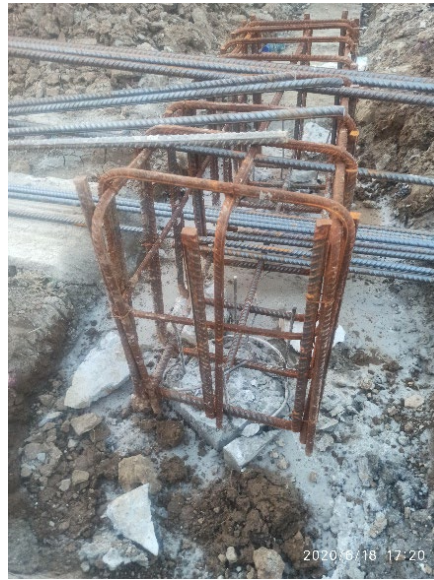
Figure 8: Iron installation before casting

The figure above shows that a concrete blanket is mandatory in the ironing process before casting. However, the necessary procedures were not followed in the field at the beginning of the project. The study identified a variety of causes. These include the absence of information on the relevant Standard Operating Procedure, poor field coordination, and unqualified field staff. The following figure shows an example of a standard operating procedure that must be communicated to the field.

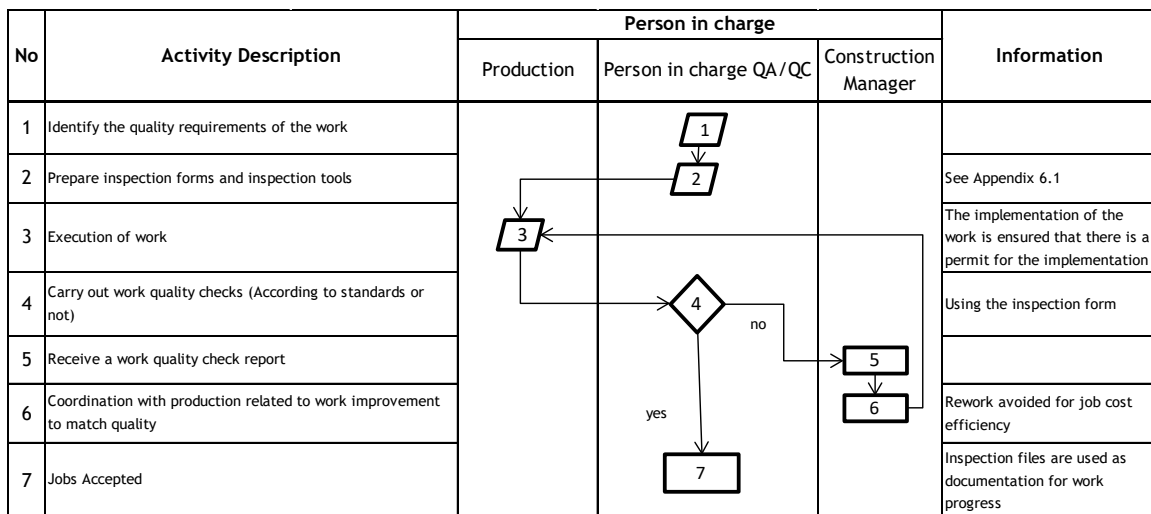
Figure 9: Job inspection flowchart

The existing Standard Operation Procedure regulated the execution of each work item. However, the field personnel never implemented these standard operating procedures. Quality measurements obtained from the QPASS tool indicated scores that were significantly below the established quality standards. The following are the QPASS scores resulting from the

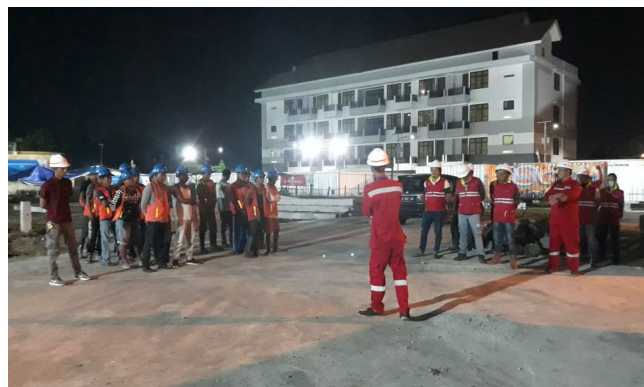
Figure 11: Safety talk at night

The Last Planner System® is the most fundamental tool in the implementation of Lean Construction. This tool also greatly affects the quality obtained. LPS® is a collaborative production planning and control system. In this project, LPS® involves the foreman, field personnel, and all vendors involved as the "final planner." The integration of LPS® with BIM software makes coordination related to work directional and has a very significant role in improving quality. One of the applications of this LPS® method is by implementing a daily huddle meeting. Through this activity, the project management team coordinates between disciplines before carrying out activities in the field. The daily huddle meeting also involves all project staff, workers, squad heads, and foremen. This activity consisted of safety talk, a toolbox meeting, and safety patrol. Safety talk activities are not only held in the morning. On some occasions it is also held at night. The following picture can be seen of safety talk activities at night and in the morning:

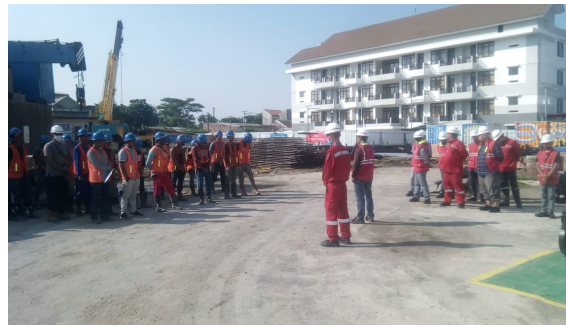
**Figure 12: Safety morning talk**

This activity plays a crucial role in the day-to-day operations of the project. Project management conveys all information regarding the quality of work to be achieved, any obstacles encountered in the field, and other work-related directives. This activity enables effective communication between field workers and project management. After the safety talk session, the agenda progresses to a toolbox meeting, as detailed below:

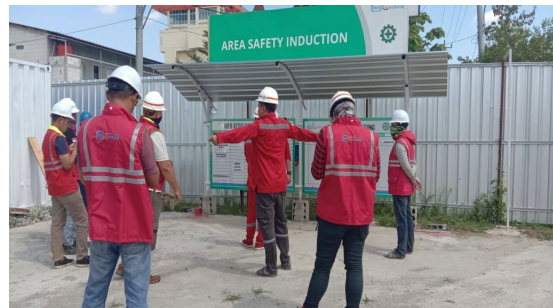
**Figure 13: Toolbox meeting**

Only staff representatives, management, and foremen from the project were at the toolbox meeting shown above. This meeting aimed to deliberate on all the construction activities scheduled for that day. The focus of this session was to review the achieved quality targets and determine the necessary corrective measures. The next agenda item after the Toolbox Meeting is completed is for project management to conduct a field inspection regarding the achievement of quality targets, progress, and other issues related to field challenges. The picture below illustrates the meeting:

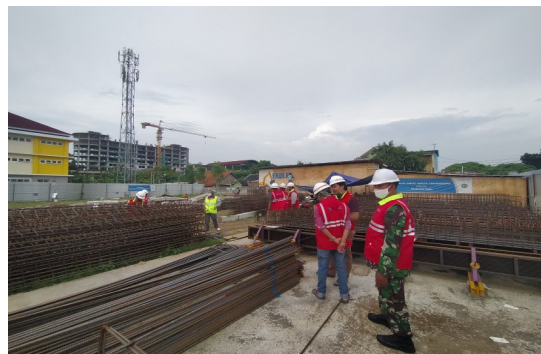
**Figure 14: Safety patrol**

This field inspection activity is known as safety patrol. The project manager always leads this activity. This activity is carried out at least once a month. The purpose of holding this safety patrol activity is to see firsthand the real conditions in the field. All problems related to quality, progress, and other non-technical problems encountered will always be followed up to find solutions. This activity aims to detect the risk of quality defects caused by miscoordination among divisions.

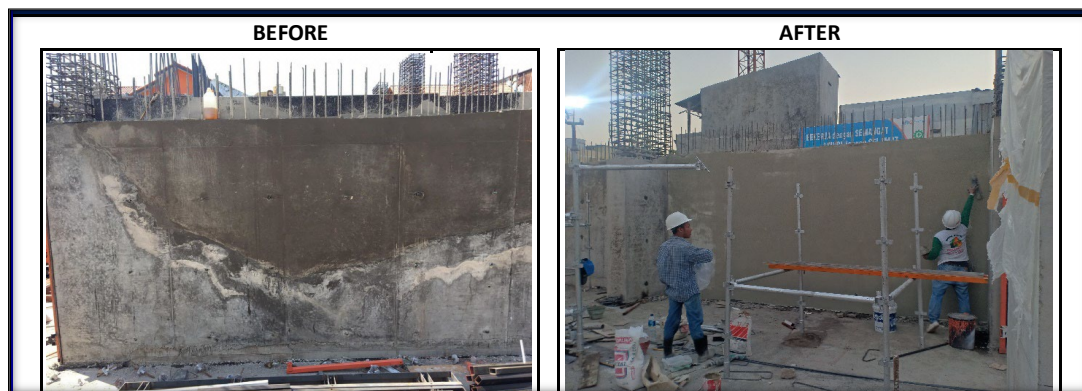
Figure 20: Corrective action

When a quality defect occurs, the project team doesn't just fix it. They use techniques like the "5 Whys," which involves asking "why" five times to identify the root cause of the problem and then designing solutions to prevent it from recurring. This is implemented through a company standard called "Deviation Notes—Corrective and Preventive Action Requests." The Deviation Log is a procedure for identifying critical deviations in a product/process, which require root cause analysis and corrective action. A deviation is a situation where the actual condition does not meet the standard. The following figure is the implementation of Deviation Notes—Corrective and Preventive Action Requests carried out by the project team to improve quality so that it can meet the set targets.

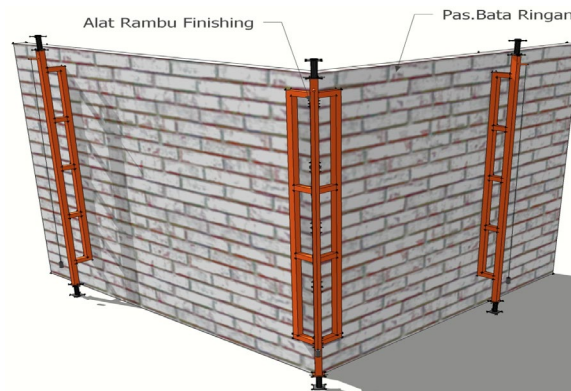
Figure 21: Finishing aid innovation

The image above shows the project team's wall installation method using a tool called a finishing signage tool. This tool help ensure the wall is installed straight and achieves the desired quality. The following image illustrates the implementation of the planned work method.

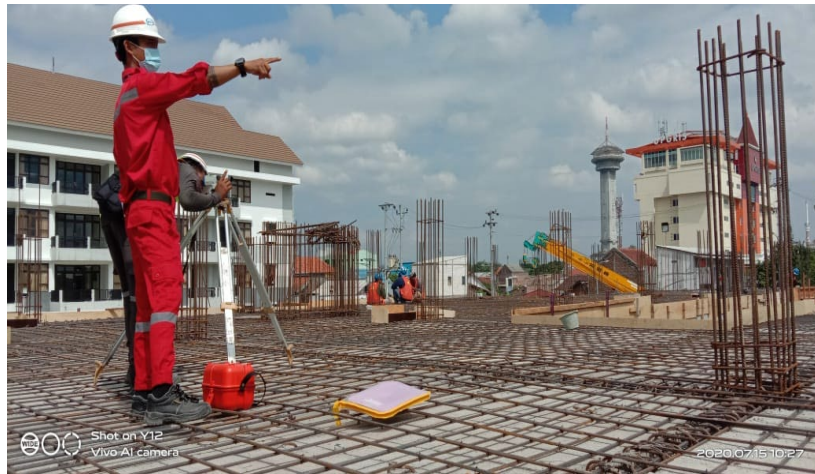
Figure 23: Preparation by safety team

Empowering workers in quality assurance and implementing the 5R concept also play a crucial role in continuous improvement efforts. Fieldwork is supervised by all project staff, from supervisors and engineers to the safety officer team. They all help monitor the quality of the work process. The following image shows the concrete floor slab casting process supervised by a safety officer.

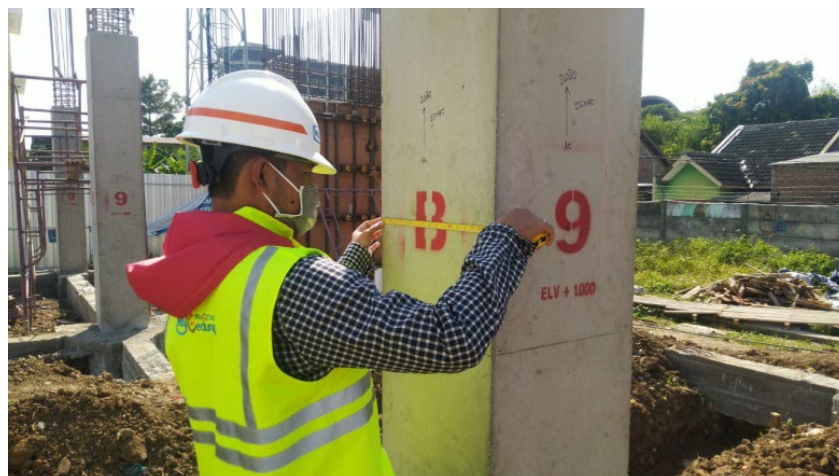
Figure 24: QPASS column structure

Figures above are part of the quality check. The assessment will be poured into the QPASS paper form, as shown below:

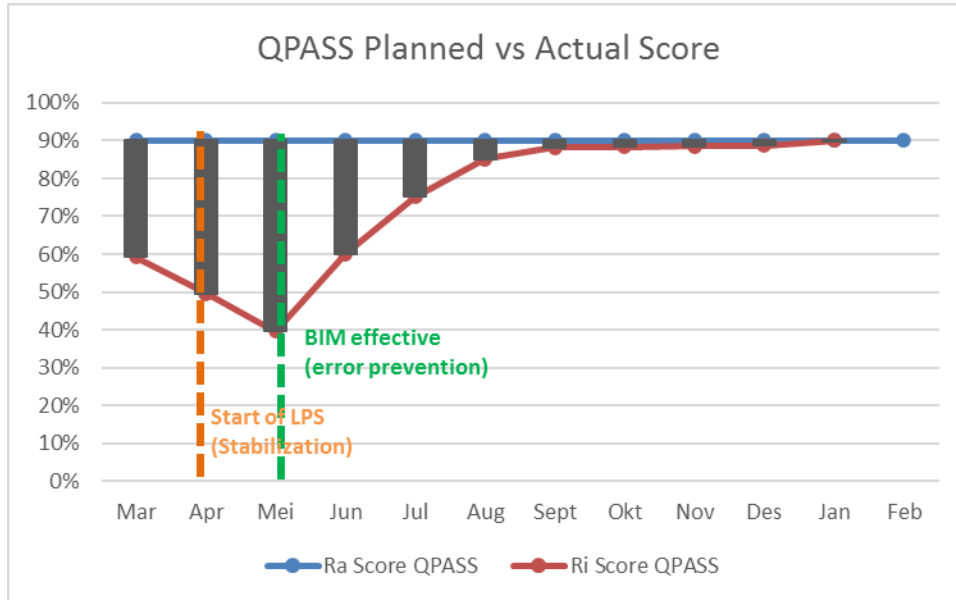
Figure 28: QPASS score increase chart

The graph above shows the increase in the QPASS score starting in June 2019. In that month, the project management team began implementing Lean Construction methods in the field. Consistency in implementing these methods is key to successfully improving project quality. When Lean Construction methods are integrated with BIM software, the quality improvement is significant. As seen in January 2020, the QPASS score reached 90%, as planned. From the results of quality performance measurements using the QPASS tool, it can be concluded that the integration of Lean Construction methods with Building Information Modeling (BIM) significantly improved quality performance on the PGRI Semarang University Apartment Construction project. The QPASS score was below 50% in the first three months, but within eight months, it improved and reached 90%, as originally planned. Meanwhile, the recommendation based on this research is that the implementation of Lean Construction methods integrated with BIM can be a requirement for construction projects in Indonesia.
